# Conservation Report

**Tara McLaughlin**

Cultural Significance of Patina

Semester 1 2020

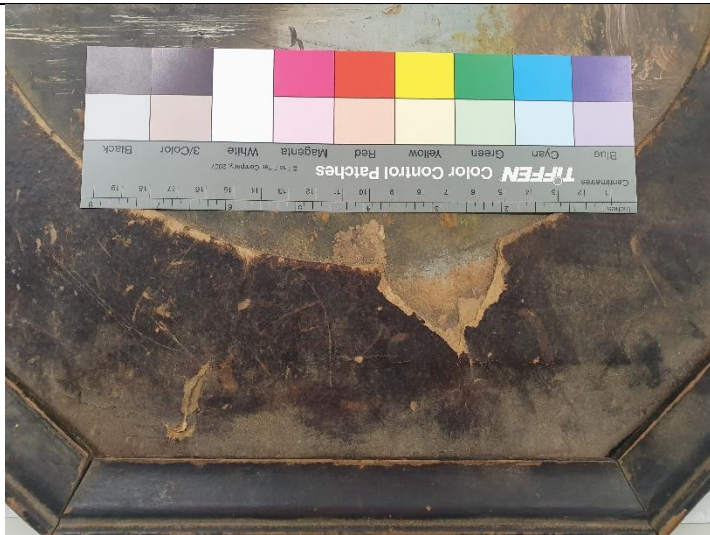
*Photograph 7: Location 1*

Type of Damage/ Deterioration	Description/deterioration	Location of damage/deterioration
<b>Chip (painting)</b>	Loss of paint material, small, although through to the backing board.	Location 5 and 6
<b>Loss (painting)</b>	A major section of paint loss, through to the backing board.	Location 1
<b>Mechanical lifting (painting)</b>	Dents and fractures likely caused by impact on the painted surface. The paint layers have mostly been affected due to the paints fine and thin application.	All sections.
<b>Abrasion (painting)</b>	Abrasions over paint surface, likely caused by object scraped across the top of the painting. This has resulted in long thin marks across the surface. In some sections, this has resulted in paint loss.	All section, detailed photo location 5 and 6.
<b>Chip (mat board)</b>	Loss of a small amount of paint material.	All section, detailed photo location 5 and 6.
<b>Loss (mat board)</b>	Major loss of mat board likely caused by object catching the edge of the board.	Location 1

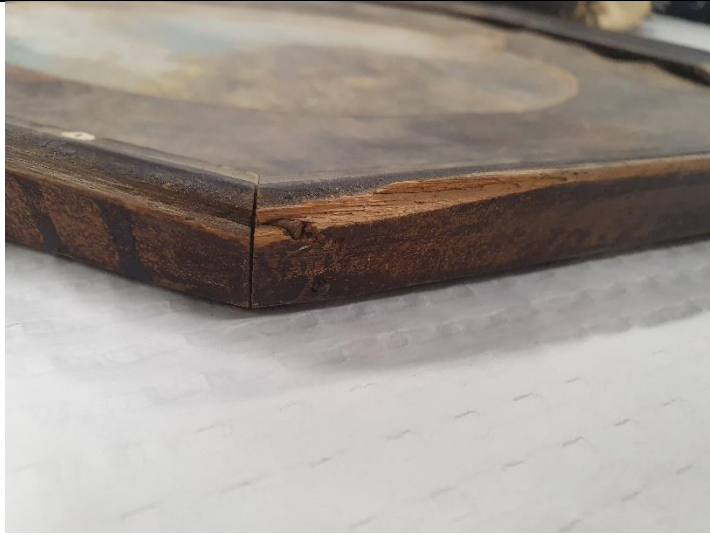
Photograph 9: Location 3

<b>Mechanical Lifting (mat board)</b>	Dents and fractures likely caused by impact to mat board's surface. This has resulted in a loss in colour.	All sections
<b>Abrasion (mat board)</b>	Abrasions over paint surface, likely caused by object scraped across the top of the painting. There are many round rings over the surface from an object like a cup. This has resulted in long thin marks across the surface. In some sections this has resulted in paint loss.	All sections. Detailed photo location 2
<b>Tear (mat board)</b>	Tear in mat board but no loss of material.	Location 1
<b>Warping (mat board)</b>	The bottom edge of the mat board is warped; this is likely due to water	Location 1
<b>Loss (frame)</b>	Loss of the corner of the frame, four (4) millimetres deep by seven (7) millimetres long. Likely caused by impact to the edge.	Location 3 and 4
<b>Loss of finish (frame)</b>	Loss of finish over the frame.	All sections.

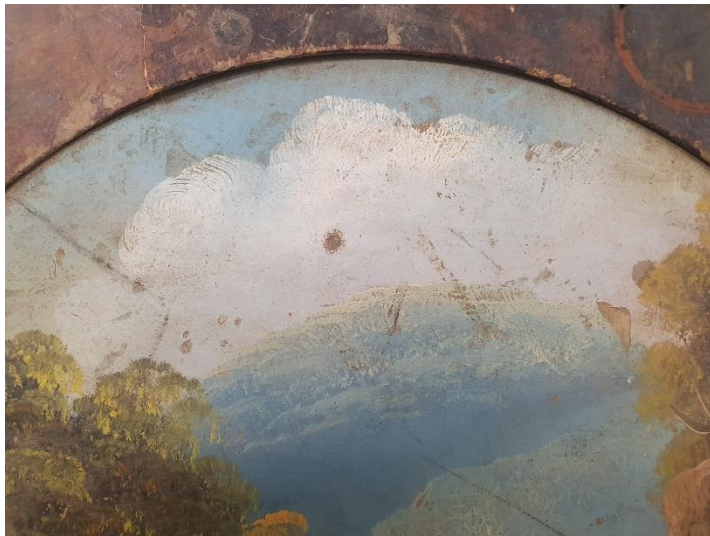
Photograph 11: Location 5

<b>Crazing (frame)</b>	The finish material is crazed. This is likely caused by the recoating of finishing with an unsuitable product, combined with weathering from outside environmental elements.	All sections. Detailed photo location 5 and 6.
<b>Mould</b>	Looks to be mould damage between the mat board and the painting backing board, mainly over the bottom edge.	Under location 1
<b>Dirt/Dust</b>	A large amount of dirt and dust cover the object surface.	All sections

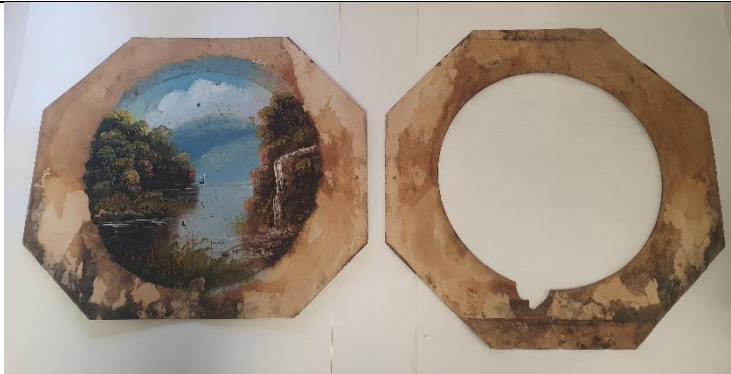
Photograph 23: Mould treatment.

The mould was treated with 70% Ethanol and 30% water. This treatment was used as it is the most efficient way to kill microorganisms. The mould is currently inactive. The finished surfaces were tested for Ethanol solubility before application (Sheerer 2012).

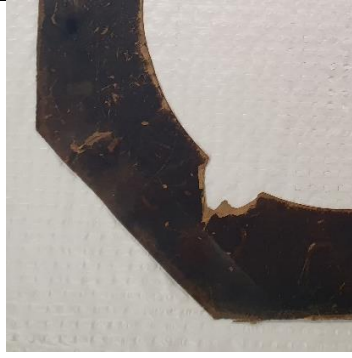
*Photograph 27: Recto mat board warped edge.*

The warping on the bottom edge of the mat board was removed through the backing process.

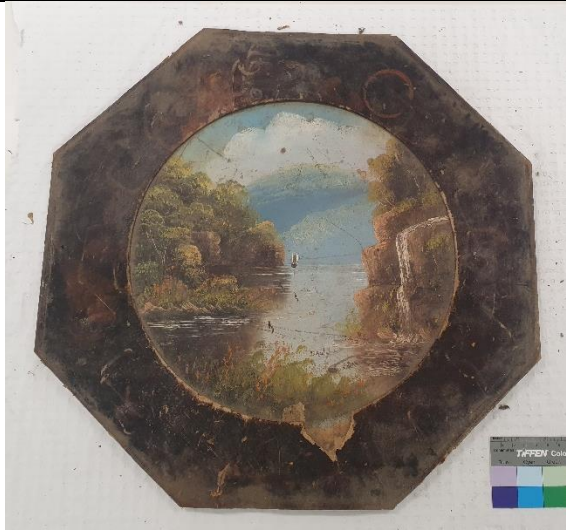
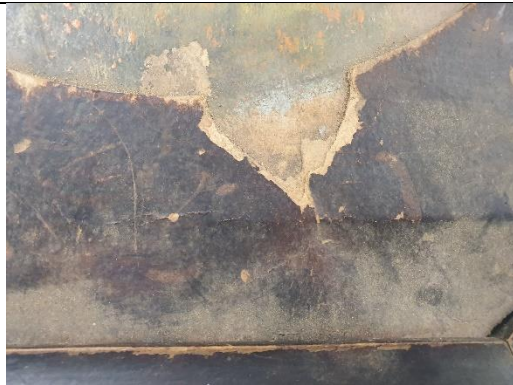
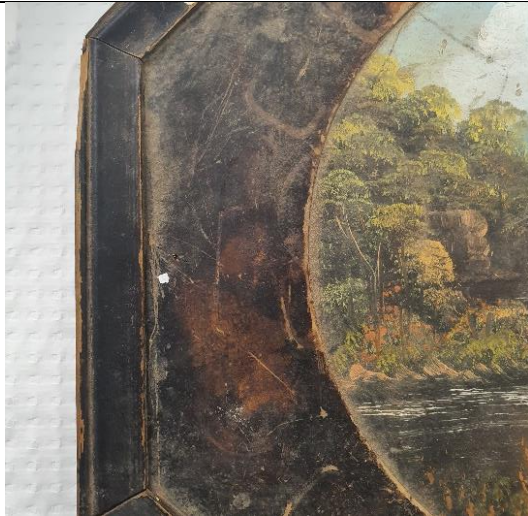
*Photograph 36: Recto before inpainting.*

*Photograph 38: Recto infill before inpainting.*

*Photograph 40: Recto before inpainting.*

The multiple sections of paint loss over the board and the paper pulp were all in-painted. All sections that required in-painting were sealed with a Methyl-Cellulose barrier (American Institute of Conservation, 2020). The losses were then in-painted with Chromacryl acrylic paint. The colours were made using variation in mixing of black, cool red and burnt umber. Tests were undertaken before application to test the gloss level of paint. Sections of the mat board needed a higher gloss level. This was achieved by applying a layer of Methyl-Cellulose over the top. (Treasure, 2020). The sections to be in-painted were carefully chosen to assist in maintaining the patina of the backboard.

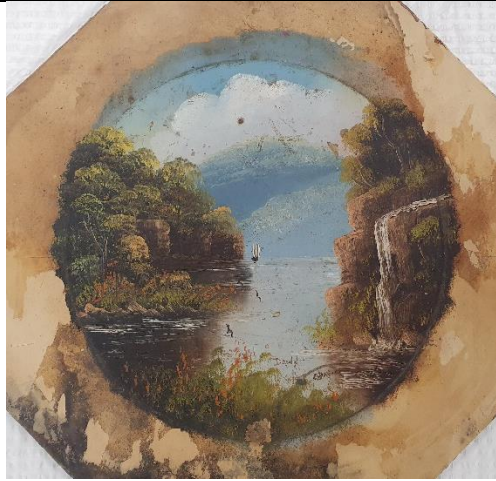
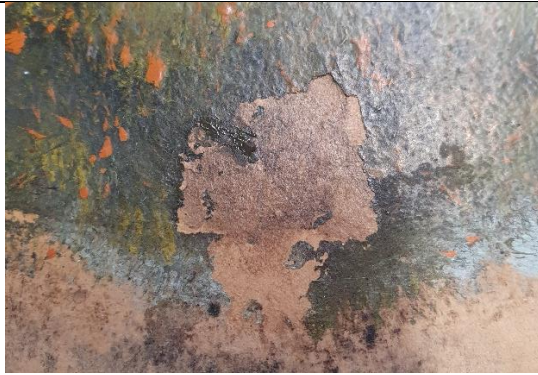
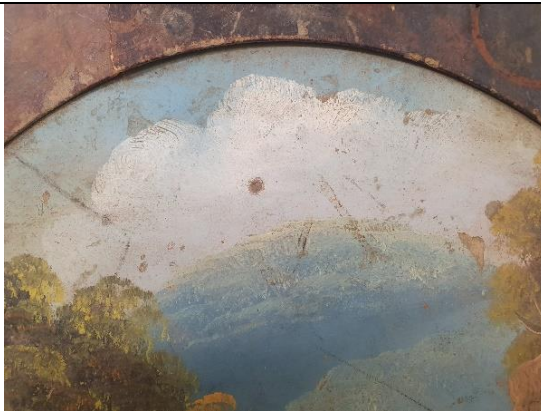
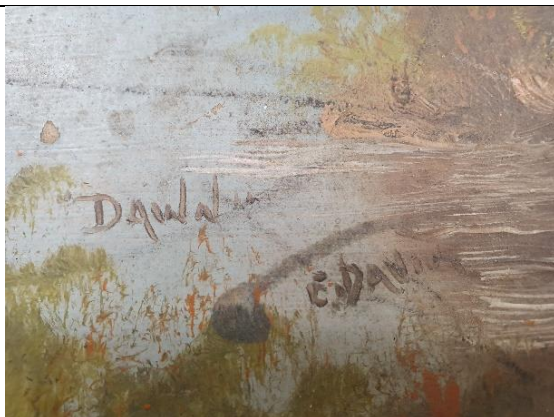
Photograph 42: Recto before inpainting.

Photograph 44: Recto loss before inpainting.

Photograph 46: Recto before inpainting.

Photograph 48: Recto before inpainting.

Loss of paint material in the small sections are through to the card. The card was sealed with a Methyl-Cellulose as a barrier (American Institute of Conservation, 2020). The losses were then in-painted with either watercolour or acrylic paint. Tests were undertaken before to ensure the correct gloss is matched (Treasure, 2020).

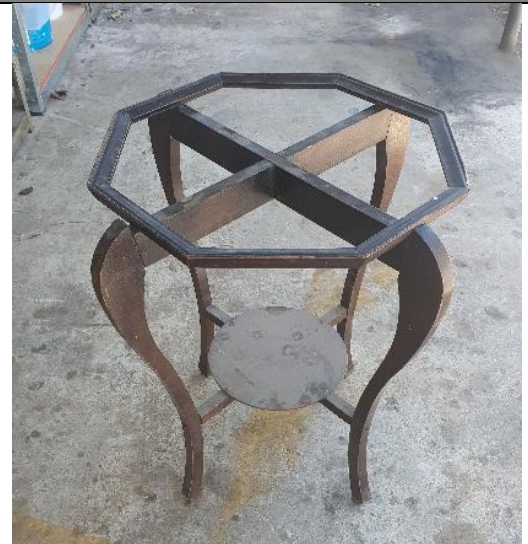
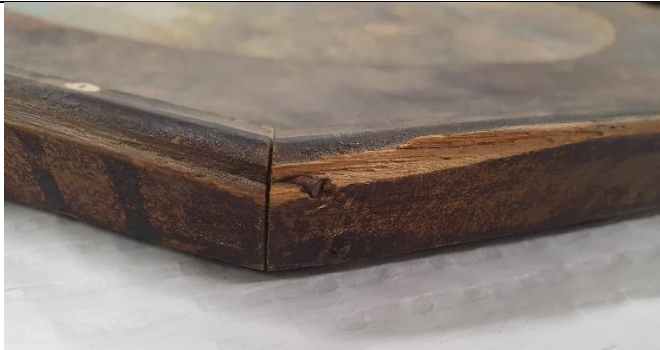
The finish on the tabletop frame and base was in extremely poor condition. The finish had been recoated with a coating that caused frying, leaving the finish crazed and unstable. The finish had to be removed as it was not keyed to timber surface. There is no way to preserve the finish and give the client their required outcome. The finish was removed using citrus stripper. This stripper was used as it allowed for the finish to be removed without damage to the timber (Minutillo, 2016).

*Photograph 50: Table base before*

*Photograph 51: Tabletop frame before*

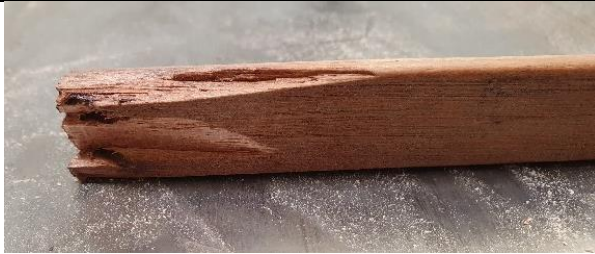
Photograph 54: Major loss before.

The major losses on the frame had a piece of timber cut to thickness to fit the space. The new timber was adhered with hide glue (Rodd 1976, p122). The joint was stopped with Timbermate wood stop to fill any small imperfection on the join, and this will ensure that there is a seamless repair at the end of the polishing process (Minutillo, 2016). The timber surface was lightly sanded to a polishable standard.
