# Conservation Report

Structure and Integrity semester 2 2019

## Condition Assessment (Before Treatment)

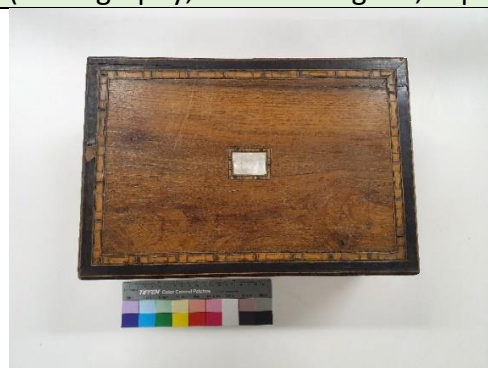
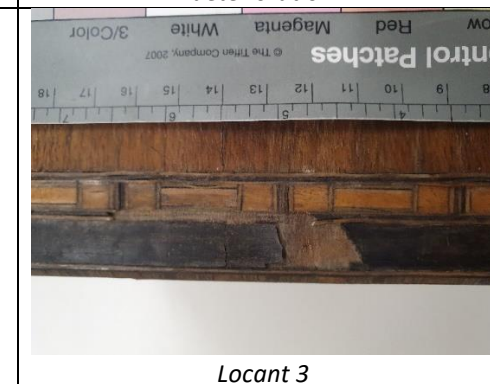
**Location:** Top of writing box

Type of Damage/ Deterioration	Description/deterioration	Location of damage/deterioration
<b>Major cracking</b>	Major crack through ebony from left corner and across back edge, approximately 8cm long.	Locant 1
<b>Minor Cracking</b>	Minor crack on Walnut on back right corner	Locant 2
<b>Veneer delamination</b>	Marquetry delaminated across right hand side	Locant 3
<b>Major losses</b>	Major loss of Ebony right side on edge.	Locant 3
<b>Minor losses</b>	Small pieces of marquetry missing throughout the top, quite small.	Locant 4
<b>Finish condition</b>	Finish has signs of water damages, opaque look through

sections.	
<b>Dirt/Dust</b>	Dirt and dust though out all cracks and over finish.	
<b>Hardware</b>	N/A	N/A

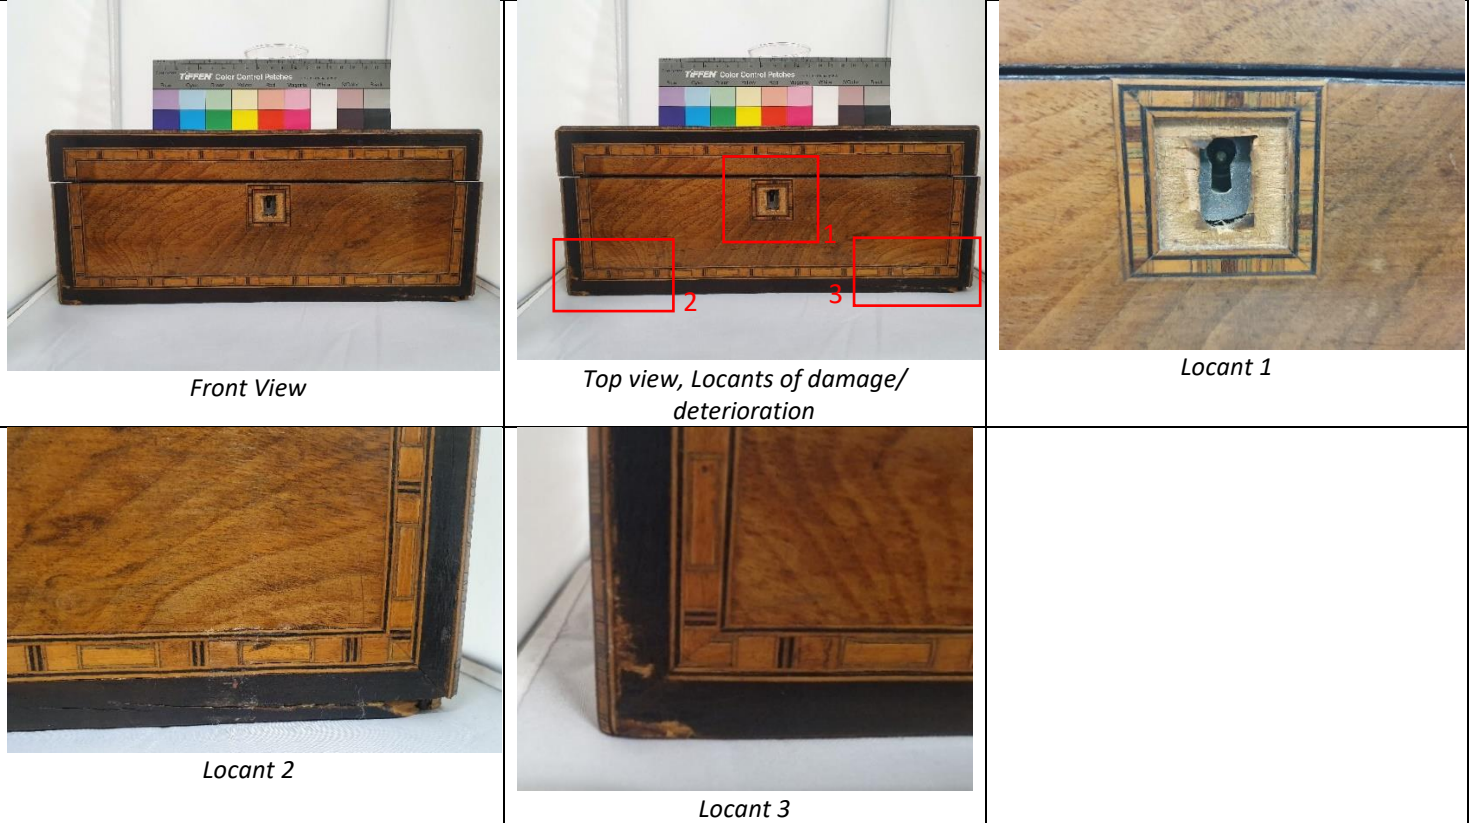
**Location: Front of writing box**  
 (Photography, Tara McLaughlin, September 2019, University of Canberra)

Type of Damage/Deterioration	Description/deterioration	Location of damage/deterioration
<b>Major cracking</b>	Minor crack leading off loss on bottom right corner	Locant 3
<b>Minor Cracking</b>	N/A	
<b>Veneer delamination</b>	N/A	
<b>Major losses</b>	Major chip and loss on bottom right hand corner.	Locant 3
<b>Minor losses</b>	Ebony has chips and losses on bottom left corner.	Locant 2
<b>Finish condition</b>	Finish has signs of water damages, opaque look through sections.	
<b>Dirt/Dust</b>	Dirt and dust throughout all cracks and over finish	
<b>Hardware</b>	Mother of pearl escutcheon missing 3cm by 3cm.	Locant 1

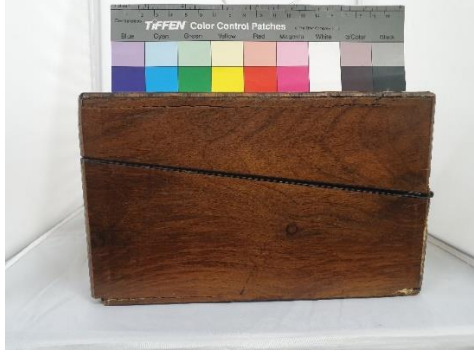
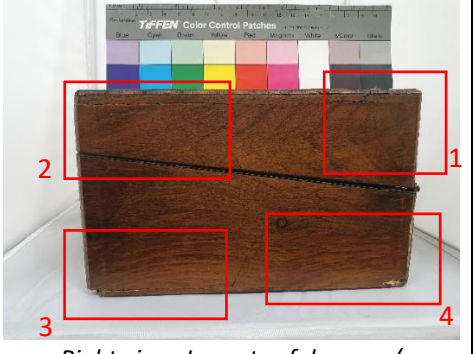
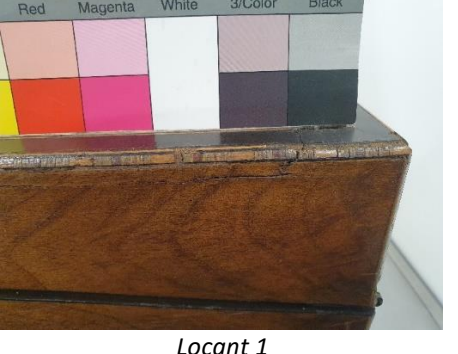
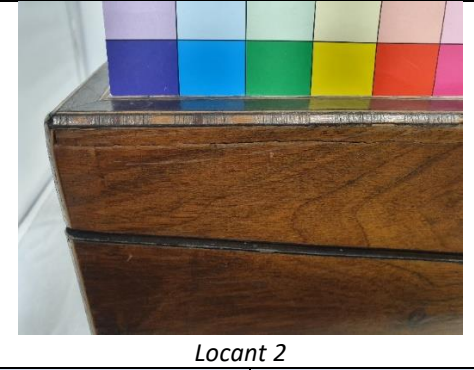
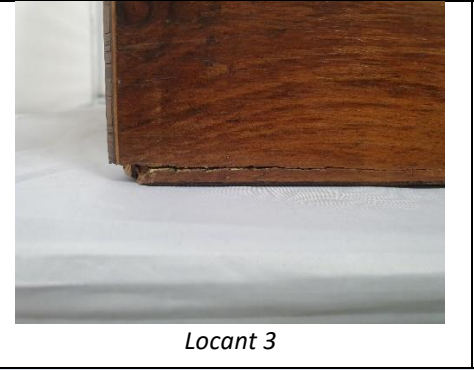
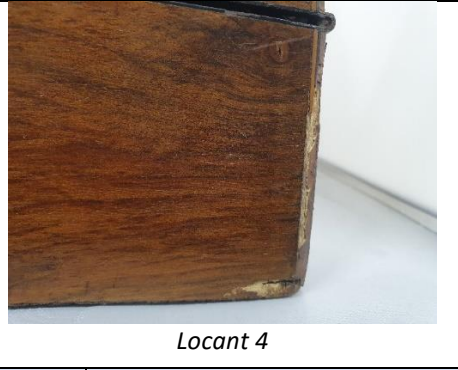
**Location: Right Side of writing box**  
 (Photography, Tara McLaughlin, September 2019, University of Canberra)

<i>Locant 2</i>	<i>Locant 3</i>	<i>Locant 4</i>
<b>Type of Damage/Deterioration</b>	<b>Description/deterioration</b>	<b>Location of damage/deterioration</b>
<b>Major cracking</b>	Crack and loss along the bottom left hand corner.	Locant 3
<b>Minor Cracking</b>	Crack line along the top edge.	Locant 2, locant 1
	Crack along the bottom left hand corner.	Locant 4
<b>Veneer delamination</b>	N/A	
<b>Major losses</b>	Loss on bottom right hand corner	Locant 3
<b>Minor losses</b>	Loss on the bottom left hand corner	Locant 4
<b>Finish condition</b>	Good condition	
<b>Dirt/Dust</b>	Dirt and dust though out all cracks and over finish	
<b>Hardware</b>	N/A	
<b>Other</b>	Old repairs on right side of box. These have Deteriorated and is delaminating from the under support timbers	Locant 4
<b>Location:</b> Left side of writing box <i>(Photography, Tara McLaughlin, September 2019, University of Canberra)</i>

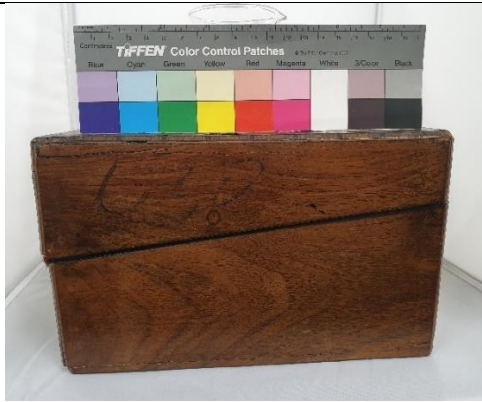
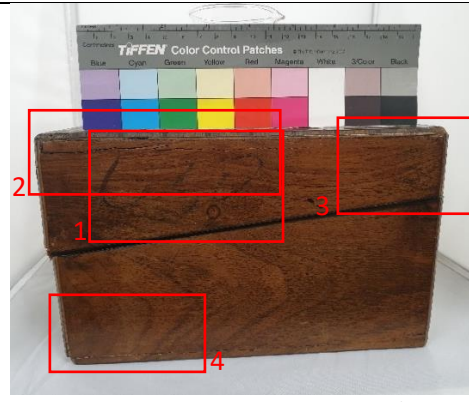
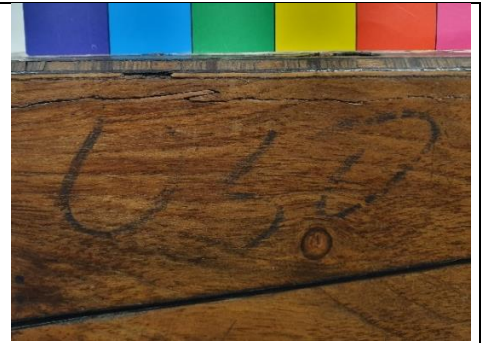
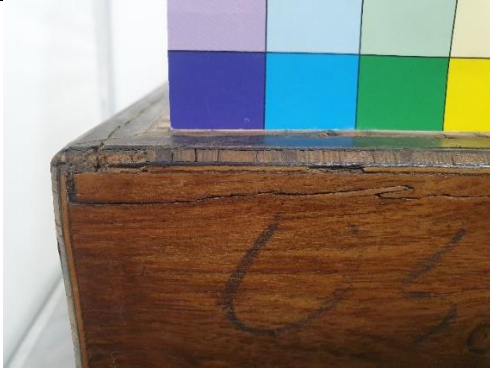
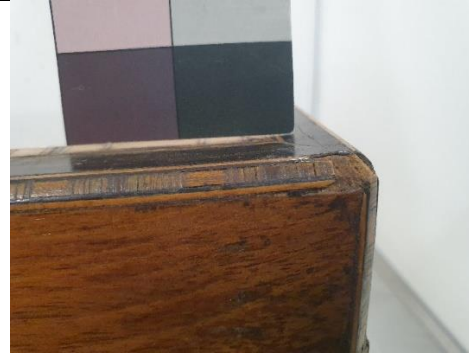
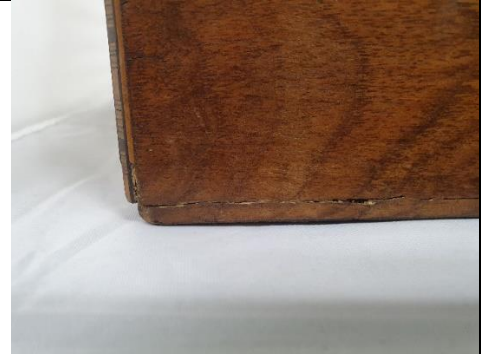
Type of Damage/Deterioration	Description/deterioration	Location of damage/deterioration
Major cracking	N/A	
Minor Cracking	Minor crack along the bottom.	Locant 4
	Minor crack along the top.	Locant 2
Veneer delamination	N/A	
Major losses	Loss on top right corner	Locant 3
Minor losses	N/A	
Finish condition	Good condition	
Dirt/Dust	Dirt and dust throughout all cracks and over finish	
Hardware	N/A	
Other	"050" written in black marker on top half.	Locant 1

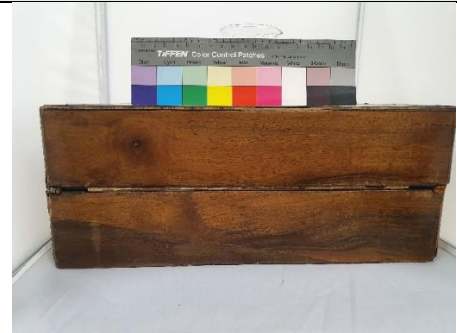
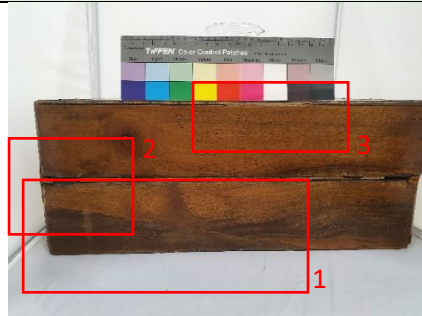
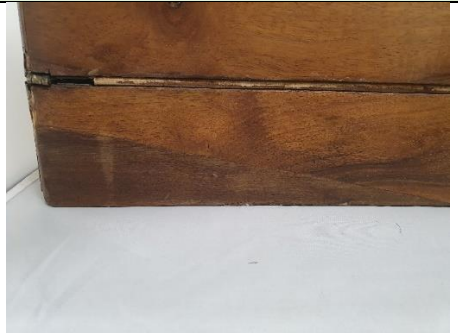
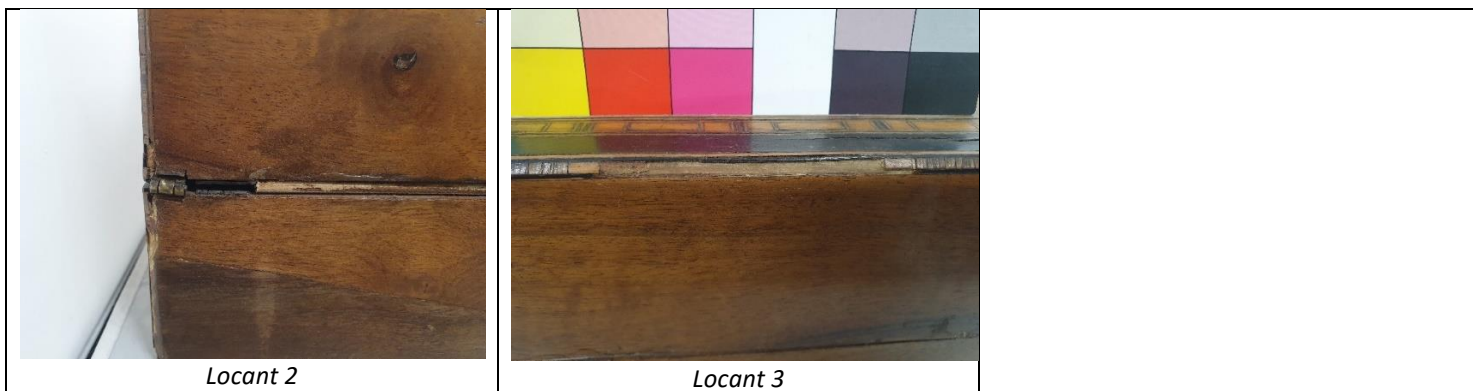
**Location: Back of writing box**  
 (Photography, Tara McLaughlin, September 2019, University of Canberra)

Type of Damage/Deterioration	Description/deterioration	Location of damage/deterioration
Major cracking	N/A	
Minor Cracking	N/A	
Veneer delamination	Old veneer cut in, has lifted across the bottom.	Locant 1
Major losses	Major loss of decorative veneered edge	Locant 3
Minor losses	Veneer has been chip on bottom right. This is due to shrinkage of the boxes timber bottom.	Locant 2
Finish condition	Finish has signs of water damages, opaque look through sections.	
Dirt/Dust	Dirt and dust though out all cracks and over finish	
Hardware	N/A	
Other	Old repair on bottom right. 200mm by 50mm triangle timber veneer has been cut in.	Locant 1

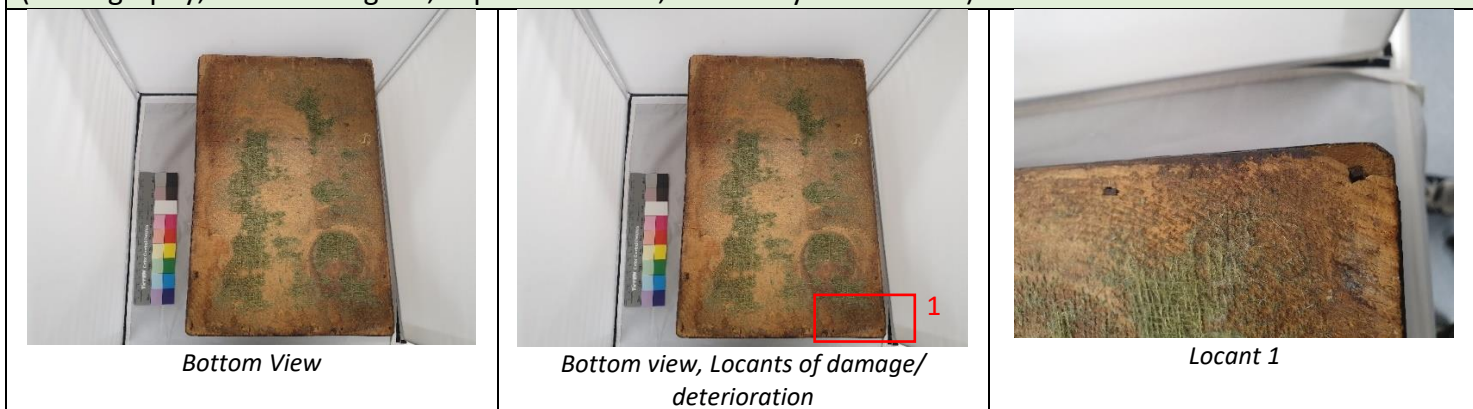
**Location: Bottom of writing box**

Type of Damage/Deterioration	Description/deterioration	Location of damage/deterioration
Major cracking	N/A	
Minor Cracking	N/A	
Veneer delamination	N/A	
Major losses	Loss on back right corner.	Locant 1
Minor losses	N/A	
Finish condition	N/A

<b>Dirt/Dust</b>	Dirt and dust throughout all cracks and over finish.	
<b>Hardware</b>	N/A	
<b>Other</b>	Only fragments of green hessian are left on the bottom side.

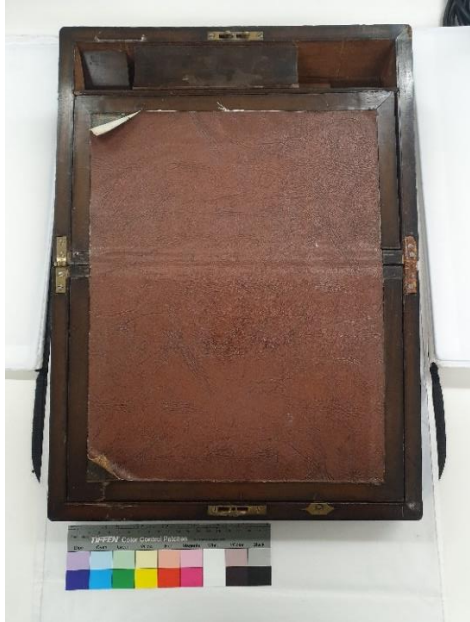
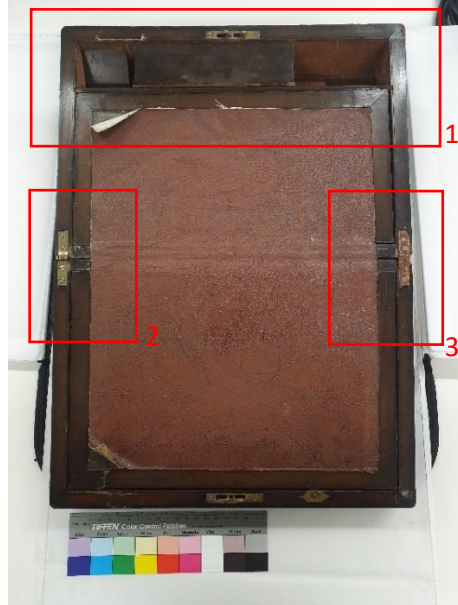
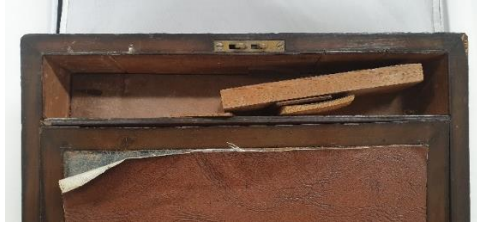
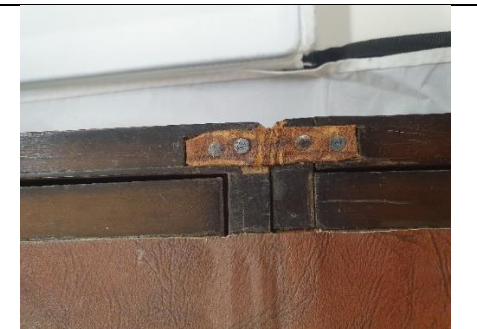
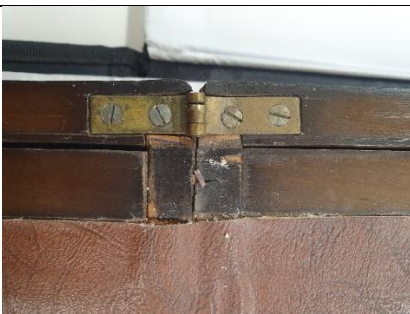
**Location: Inside of writing box**  
 (Photography, Tara McLaughlin, September 2019, University of Canberra)

Type of Damage/Deterioration	Description/deterioration	Location of damage/deterioration
<b>Major cracking</b>	N/A	
<b>Minor Cracking</b>	N/A	
<b>Veneer delamination</b>	N/A	
<b>Major losses</b>	N/A	
<b>Minor losses</b>	There are a few very minor chips throughout the inside of the box.	Locant 3
<b>Finish condition</b>	Good condition	
<b>Dirt/Dust</b>	N/A	
<b>Hardware</b>	Missing key for lock. Lock stuck in locked position.	
	One hinge is missing. This has been replaced with a leather strap.	Locant 2
<b>Other</b>	Broken divider between inkwell and pen rest.	Locant 1
	Bottom slope's catch hole has broken out on the back side.	
	Bottom slope has been affected by timber shrinkage. This has caused ridges on where the leather sits.	Figure
	The original slop covering has been removed and replaced with a leatherette.

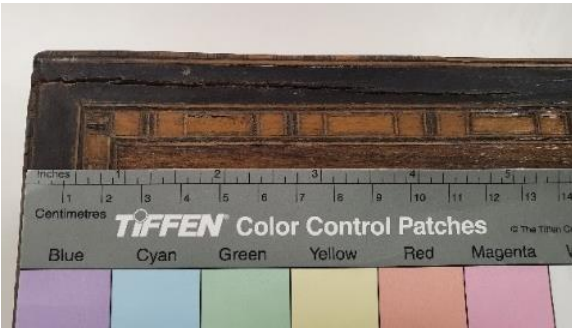
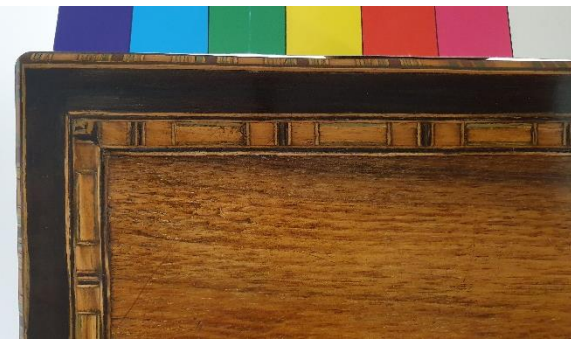
<p data-bbox="435 951 732 982"><i>Major crack on top, Before.</i></p>

<p data-bbox="1073 951 1349 982"><i>Major crack on top, After</i></p>
<b>Minor Cracking/ Timber separation</b>	Minor cracking needed to be stabilised to ensure no future damage occurs. The Minor cracking and timber separation has been found around the base/bottom of the box. The openings were injected with hide glue using a syringe, and then clamped until glue was set.

Type of damage/ Deterioration	Treatment undertaken (Photography, Tara McLaughlin, September 2019, University of Canberra)	
<b>Major cracking</b>	Major cracking needed to be stabilised to ensure no future damage occurs. To complete this, a thin piece of cedar has been cut and thickened to fit the space. Prior to inserting the thin timber with hide glue into the crack, the crack was cleaned out with a scalpel, this ensured that there was not timber splintered in the space that would affect getting good adhesion on the new timber (Rodd 1976 p122).

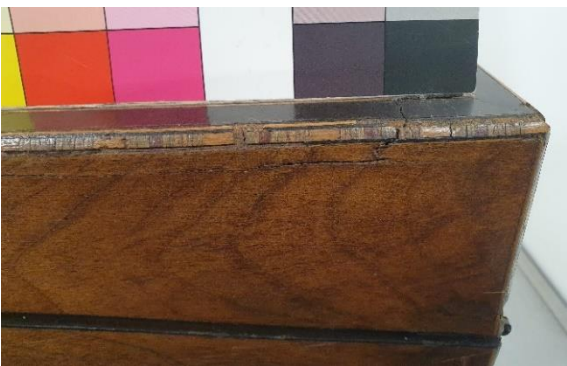
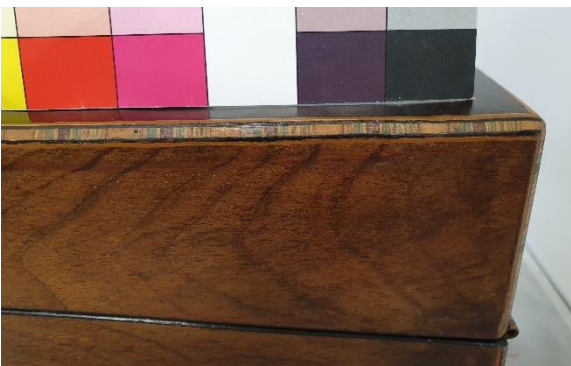
<p data-bbox="396 1602 769 1633"><i>Right side top right corner, before.</i></p>

<p data-bbox="1036 1602 1386 1633"><i>Right side top right corner, after</i></p>

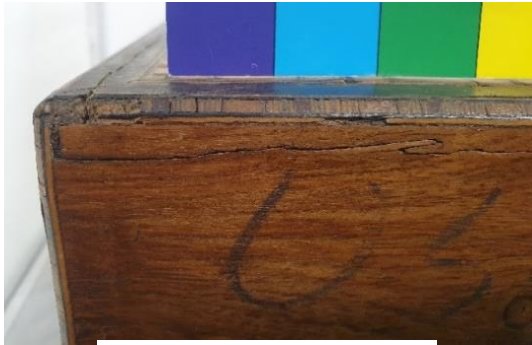
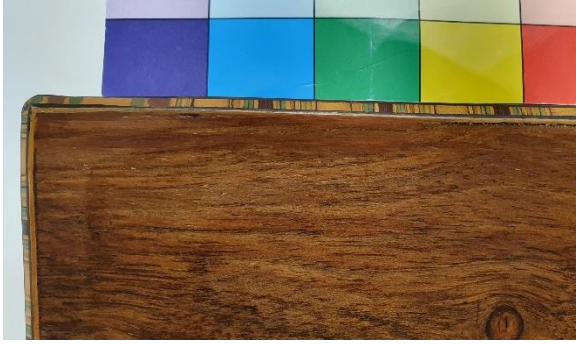
<p><i>Left side top left corner, before.</i></p>

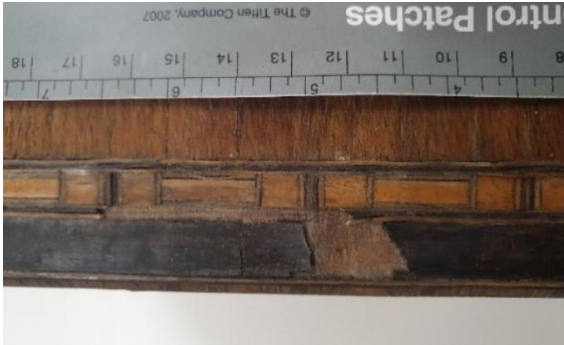
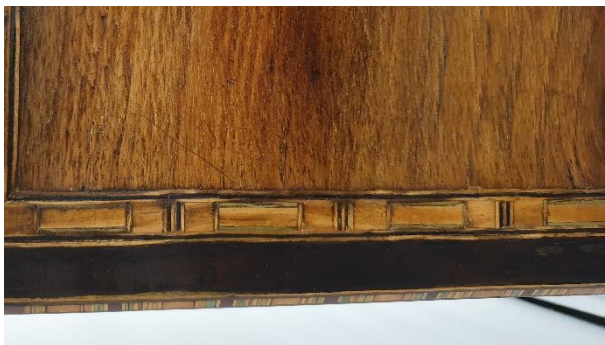
<p><i>Top right side, before.</i></p>

<p><i>Top right side, after.</i></p>

<p><i>Left side top left corner, after.</i></p>
<p><b>Veneer and marquetry delamination</b></p>	<p>The delaminated veneer and marquetry has been carefully lifted as far as the glue has failed. The sections that have bubbled had been trimmed down so that they fit into their original space. This has happened due to shrinkage of the substrate (Rodd 1976 p98). The veneer and marquetry has been injected with hide glue using a syringe, this was the best method as the needle is fine enough to be placed under without causing further damage to the veneer and marquetry (McGiffin 1992 p55). This was then clamped down with Mylar over the box surface and a timber block on top, this allowed for even pressure without the risk of damaging the surface or gluing the timber block to object.</p>

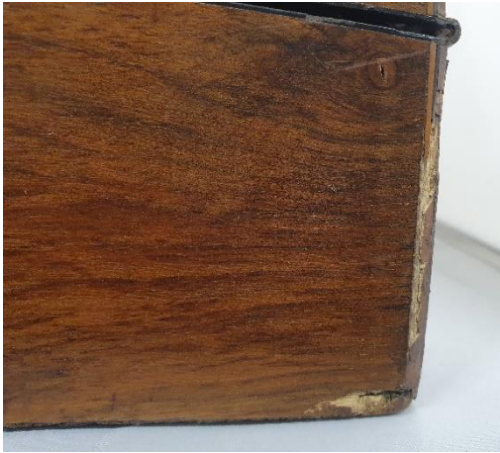
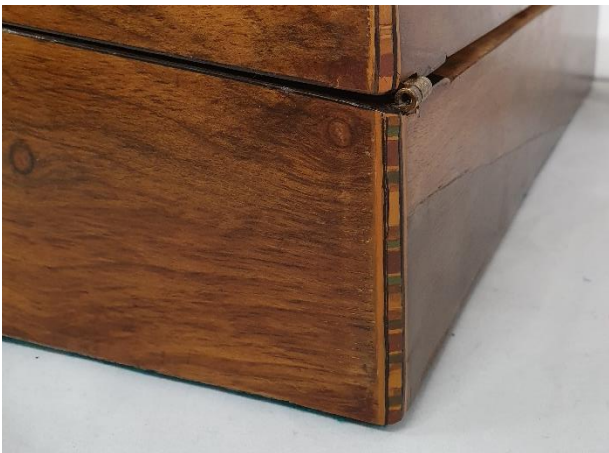
<p><i>Right side bottom right edge, before.</i></p>

<p><b>Major losses</b></p> <p>Corners/ Edges</p>	<p>The major losses on comers and edges have been filled with a two pack epoxy putty. This putty dries hard in a short period of time. Therefore, there is no shrinkage. It is well suited for larger holes and edges, corners, moulding and carving. Due to it hardness and flexibility is it well suited to rebuilding edges. The putty once dry can be carved to shape of the loss (Minutillo, 2016)..</p>

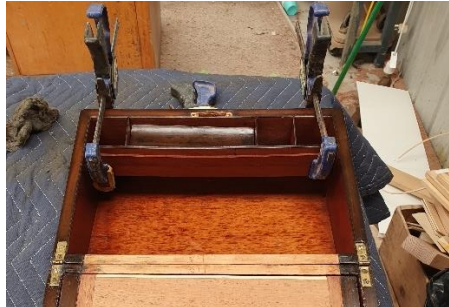
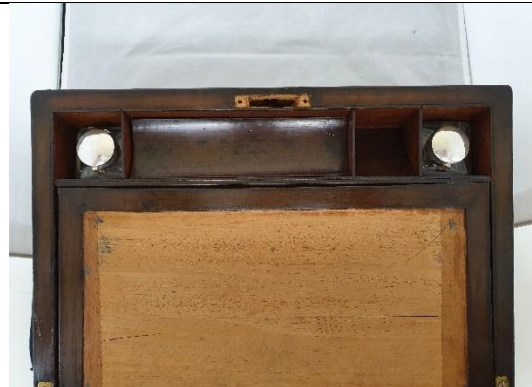
<p><i>Broken divider in clamps.</i></p>

<p><i>Photo of divider, after.</i></p>

<p><i>Felt covered bottom, after.</i></p>	
<p>Broken divider</p>	<p>The joint has been cleaned up and resecured with hide glue.</p>
