# Conservation Report

**Tara McLaughlin**

Cultural Significance of Patina

Semester 1 2020

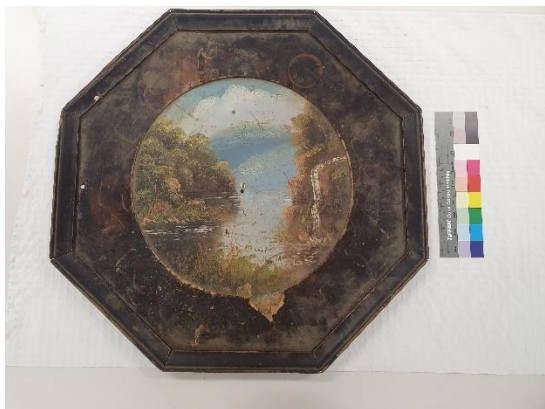
Photograph 1: Before, recto overall.

The tabletop overall is in poor condition. The painting has mutable small losses of paint material, along with a significant loss of paint material on the bottom edge. There are mutable dents and fractures from impacts on the painted surface. The painted surface has a long abrasion across the recto. The matboard also has mutable small losses of paint materials and a significant loss of board on the bottom edge. The paint material on matboard has many round rings over the surface, resulting in partial loss of the paint material. The matboard has two significant tears and warping on the bottom edge; damage looks to be caused by water. The timber frame has two significant losses on the edge. The finish on the frame is very poor condition and crazed. The tabletop has large deposits of dirt and dust over the surface.

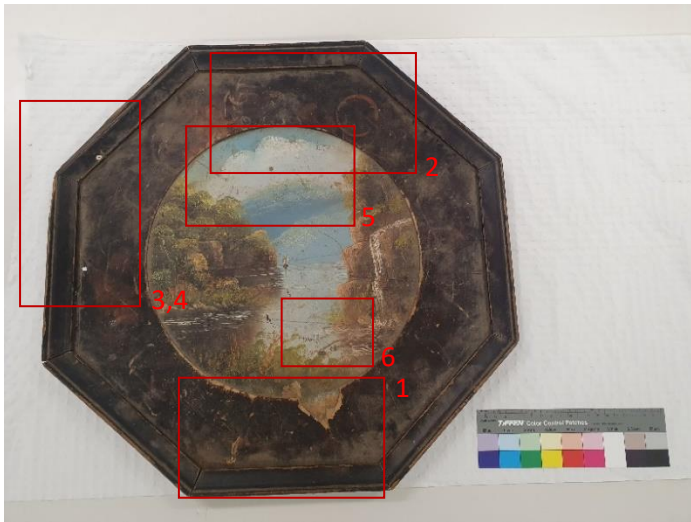
*Photograph 5: Recto Overall*

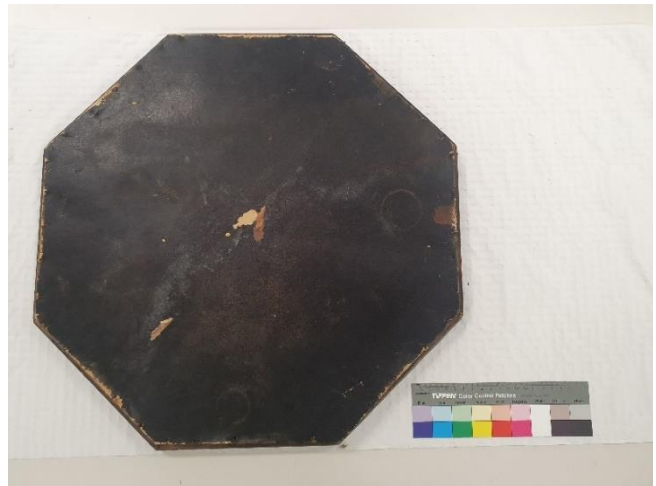
*Photograph 6: Verso Overall*

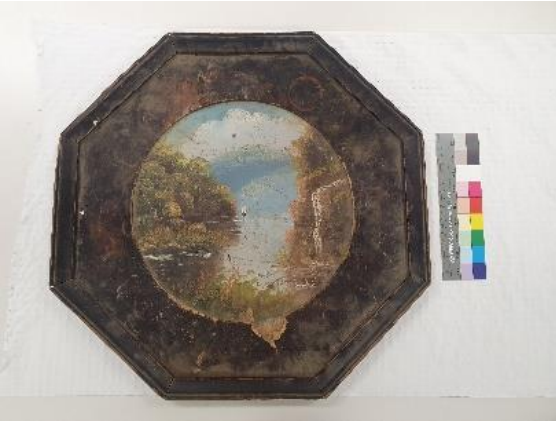
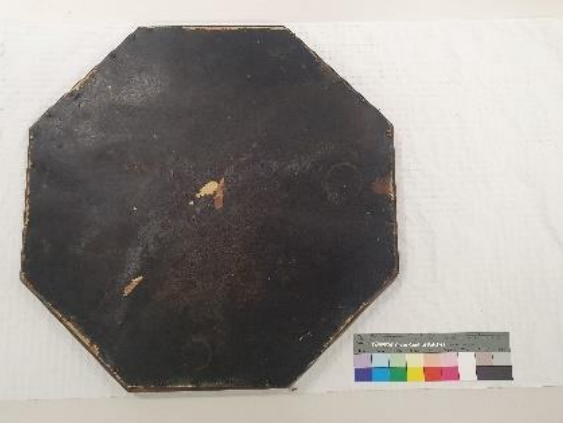
<p data-bbox="430 877 763 909"><i>Photograph 14: recto overall</i></p>

<p data-bbox="1039 877 1372 909"><i>Photograph 15: Verso overall</i></p>

Type of damage/ Deterioration	Treatment Proposal (Photography, Tara McLaughlin, February 2020, University of Canberra)	
1. Mechanical cleaning	The surfaces of the tabletop were cleaned using mechanical cleaning methods to remove the dirt and dust. All surfaces have been brush vacuumed followed by dry brushing.

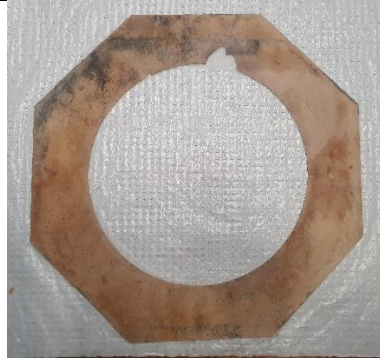
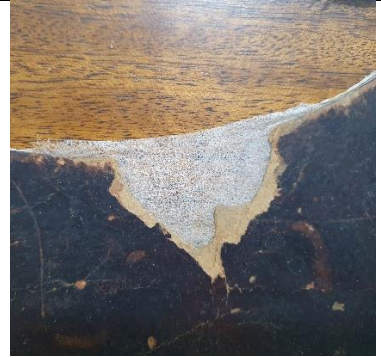
*Photograph 28: Verso mat board after backing.*

*Photograph 29: Recto mat board after backing.*

The tear in the mat board needed backing to give support to the split and to other sections of loss over the mat board. The board was backed using Tengucho paper (Weight 5.0g/m<sup>2</sup>) using the following method (Batterham, 2020):

The warping on the bottom edge of the mat board was removed through the backing process.

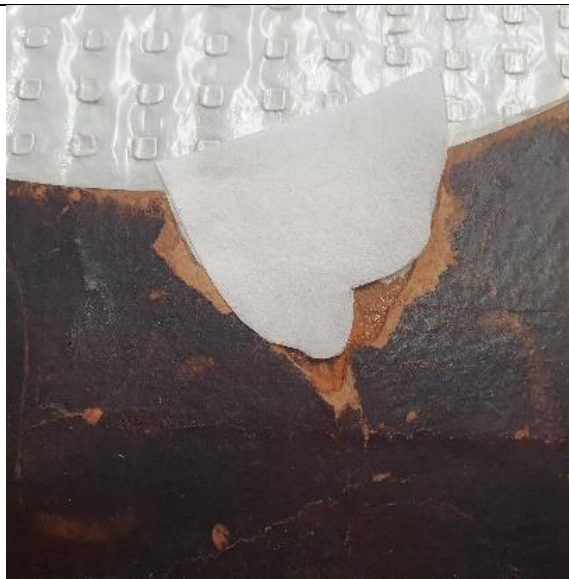
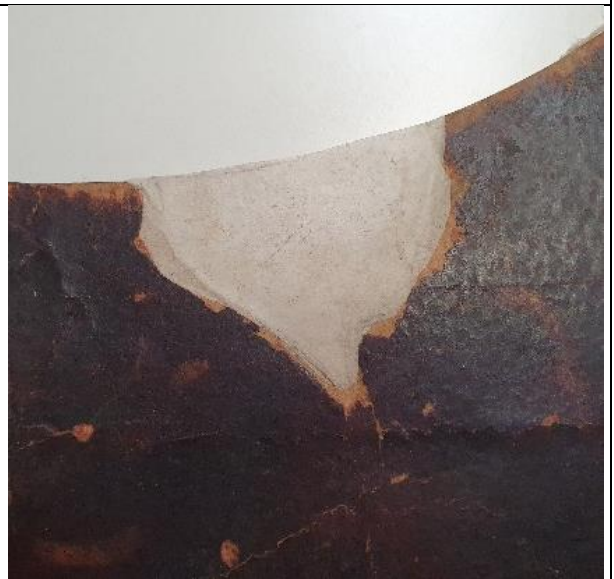
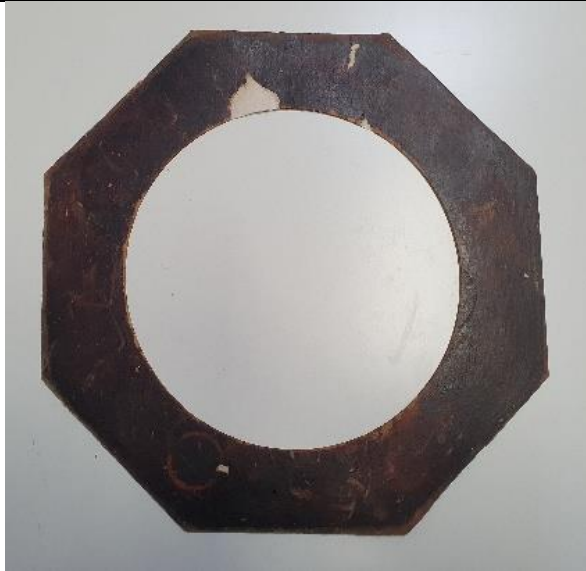
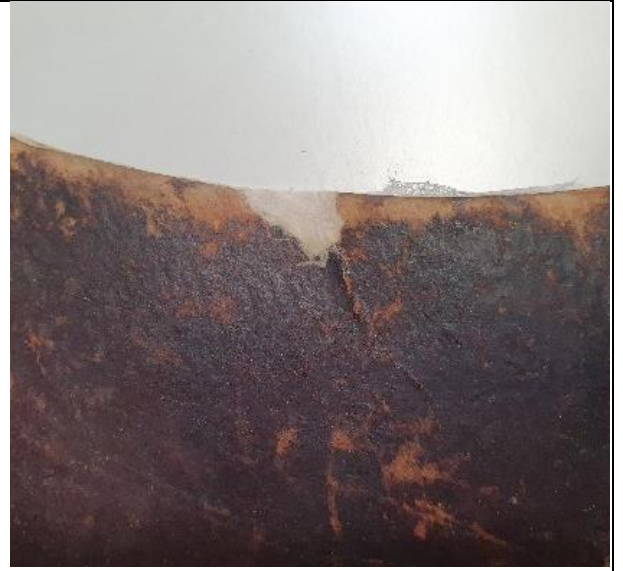
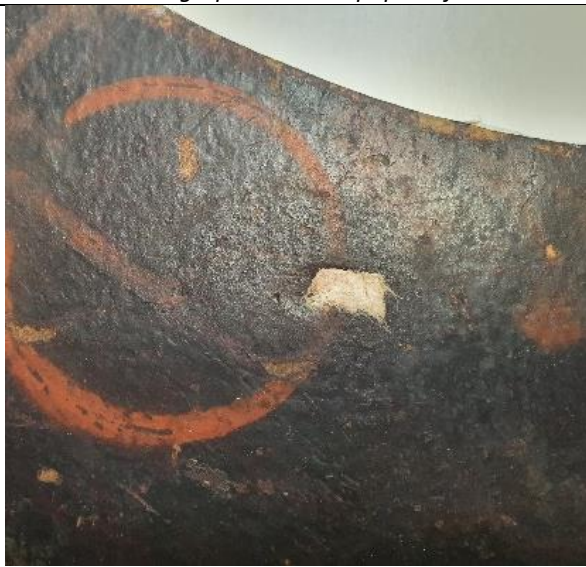
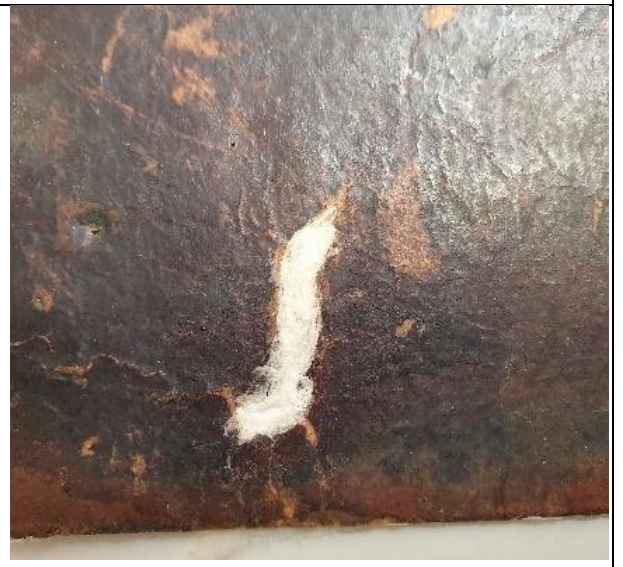
*Photograph 30: Recto paper infill.*

The tear was filled using Kozo paper (Weight: 70g/m<sup>2</sup>) this was laid in layers as the tear is ripped and steps through the layers of the card. Methyl -Cellulose was used as the adhesive. The smaller section around the outside that needed extra fill to give a flat and uniform finish was filled using Japanese tissue fibres and Methyl-Cellulose as the adhesive. Smaller sections of loss also required fill with Japanese tissue fibres. (Batterham 2020).

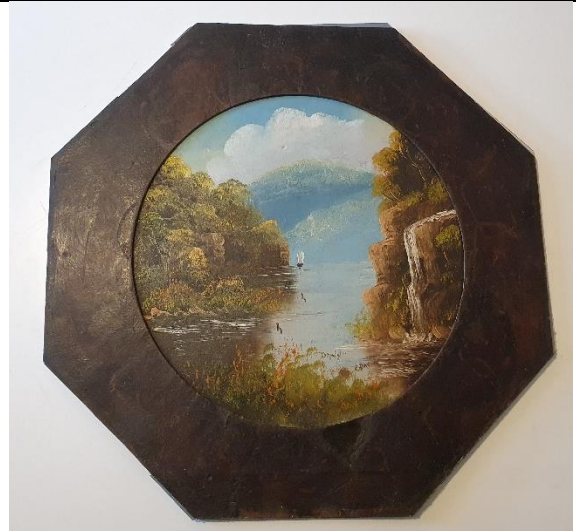
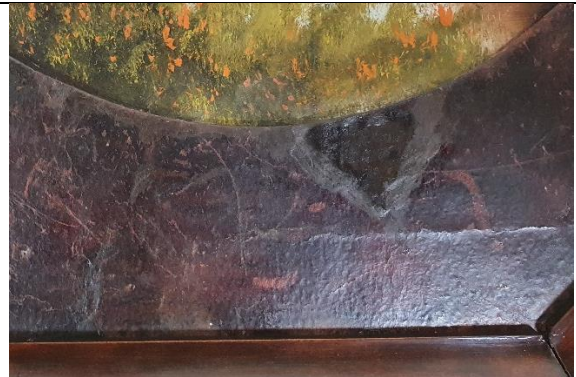
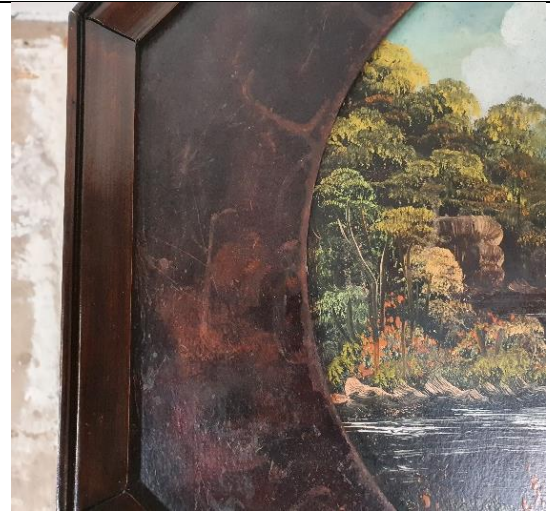
*Photograph 37: Recto after inpainting.*

*Photograph 39: Recto infill after inpainting.*

*Photograph 41: Recto after inpainting.*

The multiple sections of paint loss over the board and the paper pulp were all in-painted. All sections that required in-painting were sealed with a Methyl-Cellulose barrier (American Institute of Conservation, 2020). The losses were then in-painted with Chromacryl acrylic paint. The colours were made using variation in mixing of black, cool red and burnt umber. Tests were undertaken before application to test the gloss level of paint. Sections of the mat board needed a higher gloss level. This was achieved by applying a layer of Methyl-Cellulose over the top. (Treasure, 2020). The sections to be in-painted were carefully chosen to assist in maintaining the patina of the backboard.

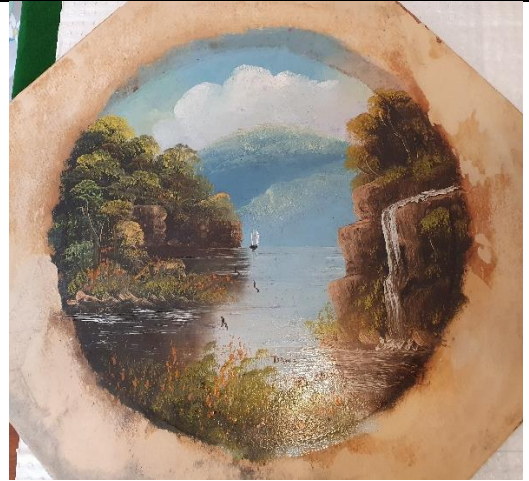
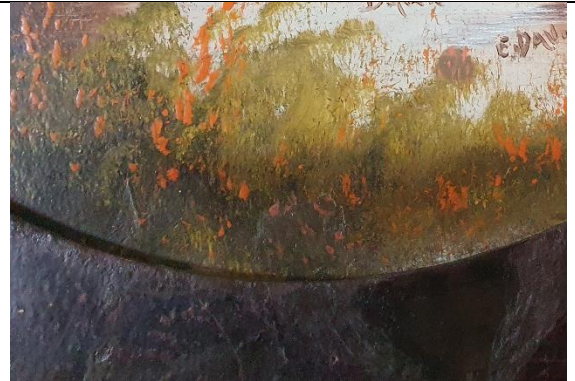
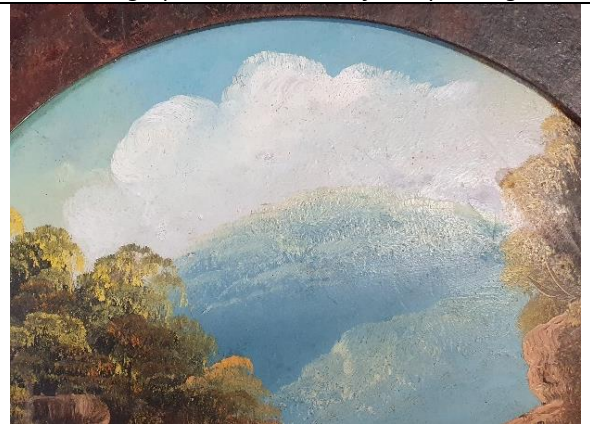
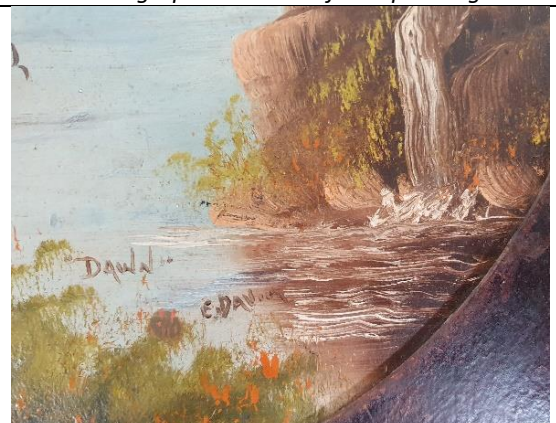
Photograph 43: Recto after inpainting.

Photograph 45: Recto loss after inpainting.

Photograph 47: Recto after inpainting.

Photograph 49: Recto after inpainting.

Loss of paint material in the small sections are through to the card. The card was sealed with a Methyl-Cellulose as a barrier (American Institute of Conservation, 2020). The losses were then in-painted with either watercolour or acrylic paint. Tests were undertaken before to ensure the correct gloss is matched (Treasure, 2020).

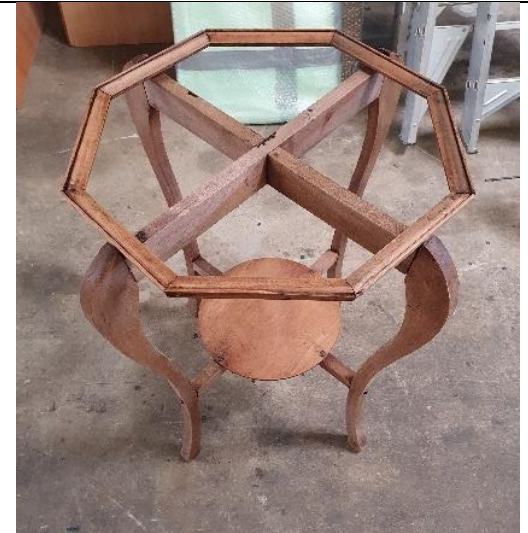
*Photograph 52: Table base after finish removal.*

The finish on the tabletop frame and base was in extremely poor condition. The finish had been recoated with a coating that caused frying, leaving the finish crazed and unstable. The finish had to be removed as it was not keyed to timber surface. There is no way to preserve the finish and give the client their required outcome. The finish was removed using citrus stripper. This stripper was used as it allowed for the finish to be removed without damage to the timber (Minutillo, 2016).

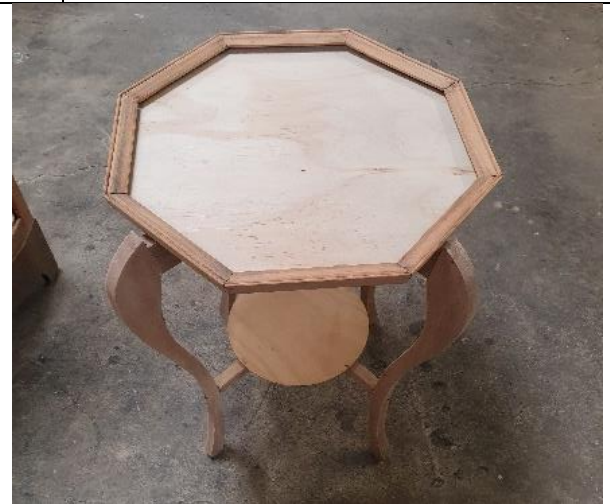
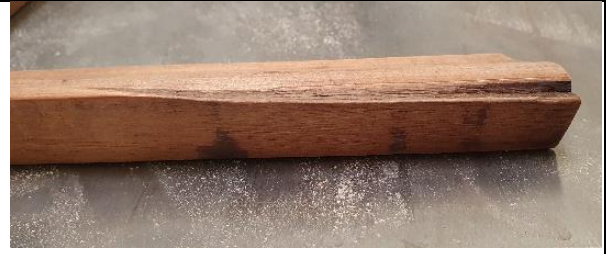
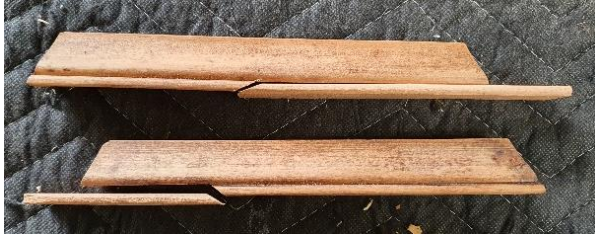
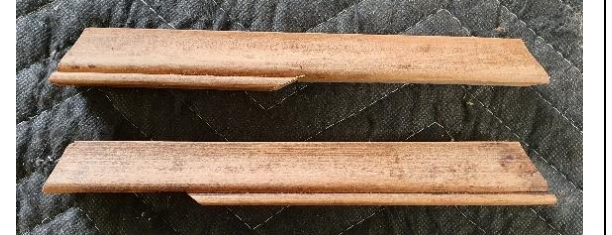
*Photograph 53: Base and top after preparation.*

Photograph 55: major loss after.

Photograph 56: major loss with new timbers.

Photograph 57: Major loss after cutting.

The major losses on the frame had a piece of timber cut to thickness to fit the space. The new timber was adhered with hide glue (Rodd 1976, p122). The joint was stopped with Timbermate wood stop to fill any small imperfection on the join, and this will ensure that there is a seamless repair at the end of the polishing process (Minutillo, 2016). The timber surface was lightly sanded to a polishable standard.

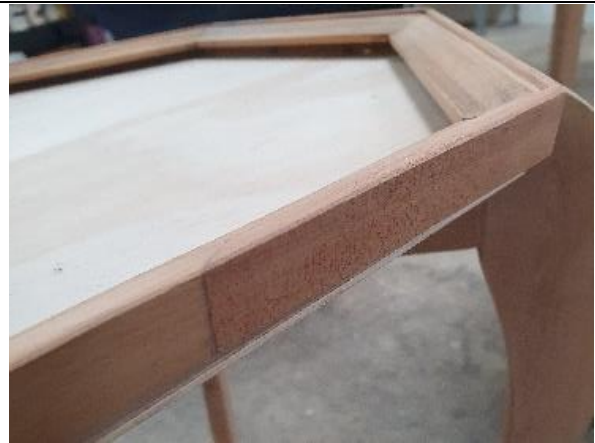
Photograph 58: Cut in after preparation and reassembly.

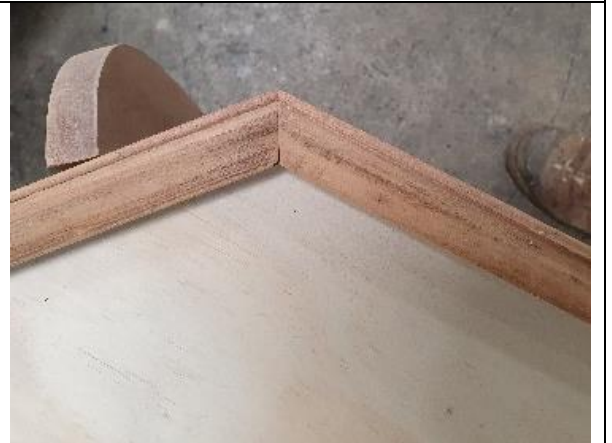
Photograph 59: Cut in after preparation and reassembly.

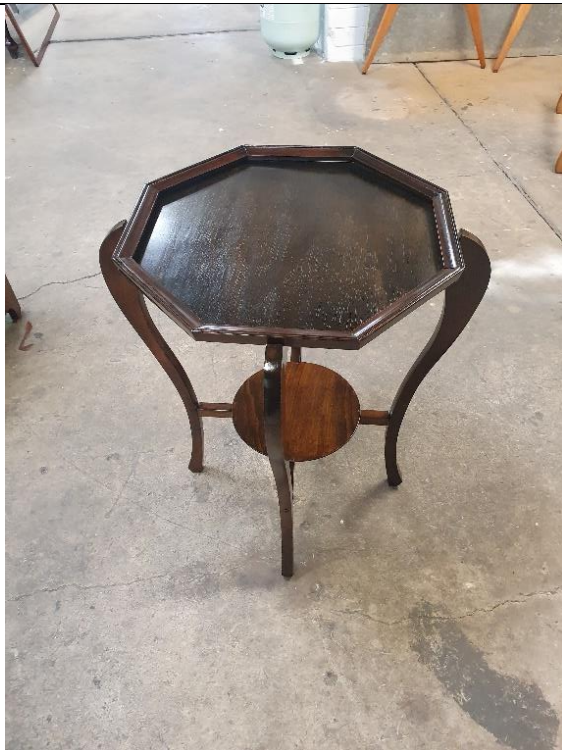
*Photograph 62: Table base after polishing before waxing.*

The frame has been stained using pigment oil stain. The stain was made by using eight parts turpentine, four parts linseed oil and one-part terebene, then burnt umber and black carbon pigment is mixed until the desired colour was achieved. The stain is required to dry for 24 hours before sealing. The table has been finished using traditional French polish methods, using shellac. Shellac is a fast-drying evaporative coating characterised by exceptional clarity and depth. Shellac consists of resin (orange shellac flake) and alcohol (methylated spirits), mixed at 250g of flake to 1 Litre of methylated spirits. To blend repairs, they were grained (in-painted) after the sealing coat of shellac. For the in-painting, pigment colours were used to match the colour. The pigments were dissolved in shellac (using a

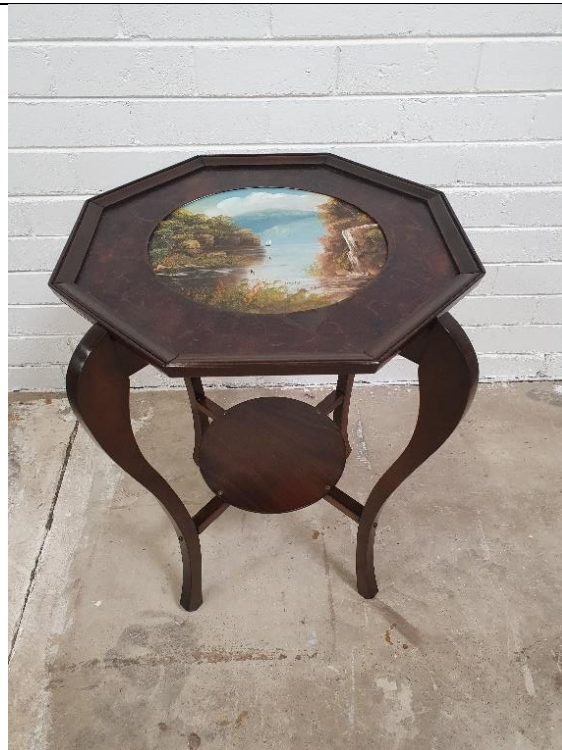
*Photograph 63: Table base after waxing and assembly.*

blinder) and methylated spirits, as the thinning agent, to ensure a good flow of colour (Minutillo, 2016). The finish has then been waxed with dark cabinet wax, used to enhance the finish, and give it protection from light and daily use.

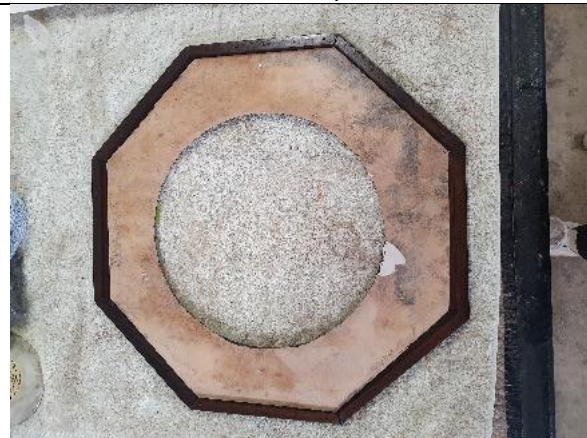
*Photograph 64: Mat board in the frame.*

The painting has been remounted in the frame. The matboard was placed into the frame with thin archival card cut to the same shape and placed on top. This is to give a barrier layer between the painting and mat board. The painting was then placed in the frame with blue fluted archival card on top to give protection to the painting.

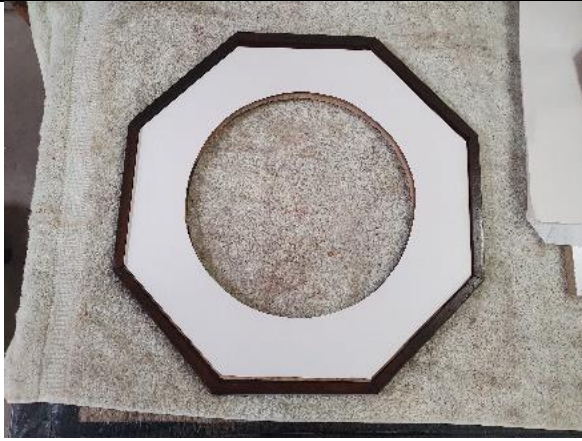
*Photograph 65: Mat board and archival card in the frame.*

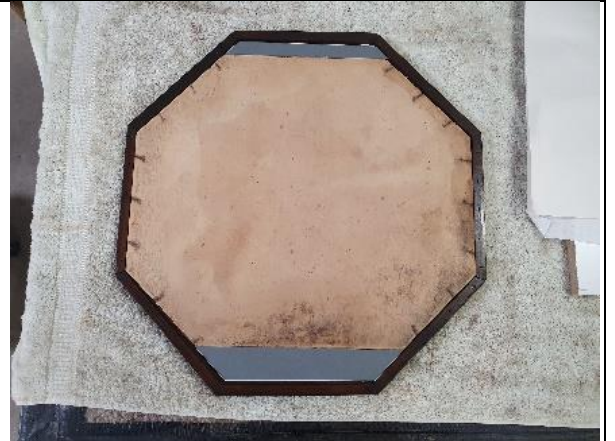
*Photograph 66: Mat board, archival card and painting in a frame.*

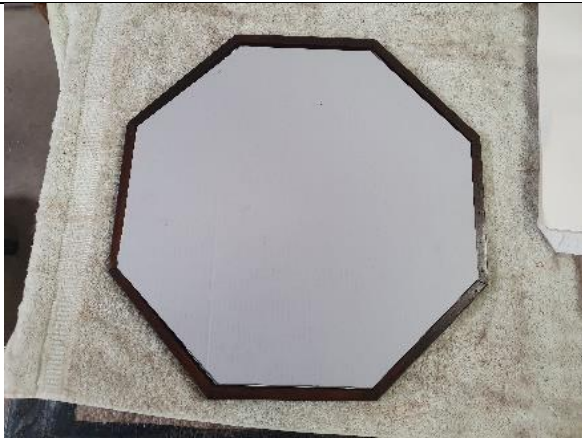
*Photograph 67: Mat board, archival card, painting and fluted arrival card in the frame*

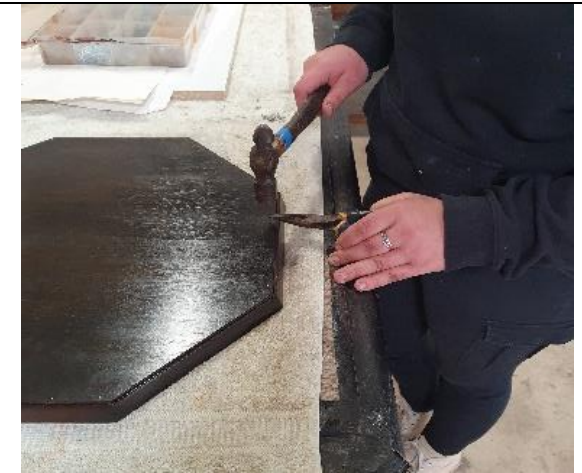
*Photograph 68: Nailing on backboard.*
