# Conservation Report

Structure and Integrity semester 2 2019

## Condition Assessment (Before Treatment)

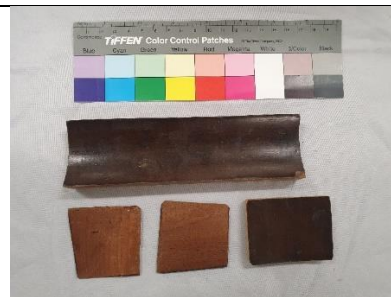
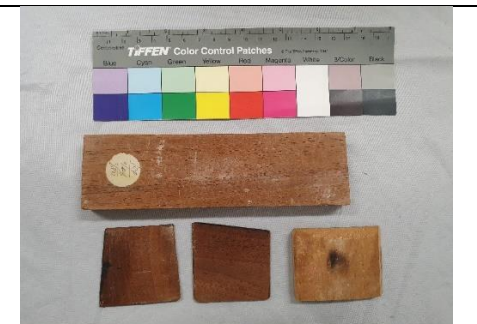
*Front, Inkwell and pen rest pices*

*Back, Inkwell and pen rest pices*

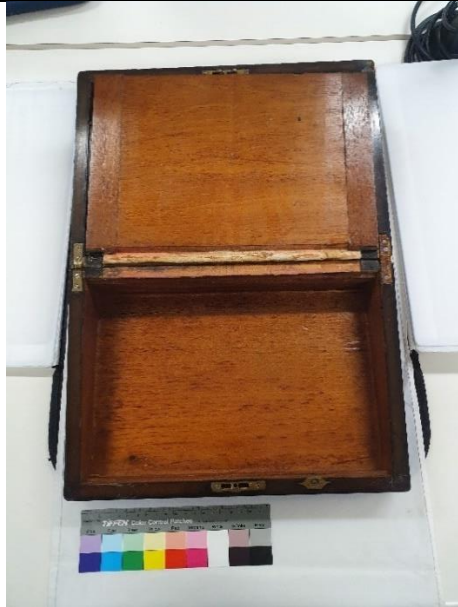
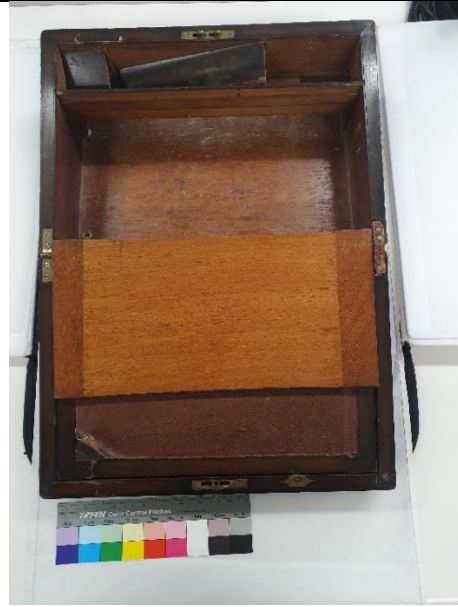
*Bottom Slop open*

*Top slop open*

Type of Damage/Deterioration	Description/deterioration	Location of damage/deterioration
<b>Major cracking</b>	N/A	
<b>Minor Cracking</b>	N/A	
<b>Veneer delamination</b>	N/A	
<b>Major losses</b>	N/A	
<b>Minor losses</b>	There are a few very minor chips throughout the inside of the box.	Locant 3
<b>Finish condition</b>	Good condition	
<b>Dirt/Dust</b>	N/A	
<b>Hardware</b>	Missing key for lock. Lock stuck in locked position.	
	One hinge is missing. This has been replaced with a leather strap.	Locant 2
<b>Other</b>	Broken divider between inkwell and pen rest.	Locant 1
	Bottom slope's catch hole has broken out on the back side.	
	Bottom slope has been affected by timber shrinkage. This has caused ridges on where the leather sits.	Figure
	The original slop covering has been removed and replaced with a leatherette.

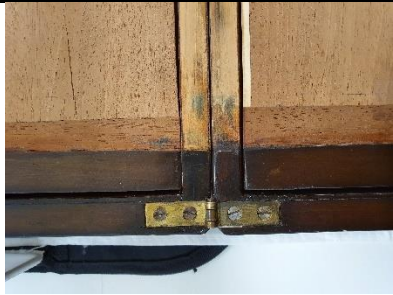
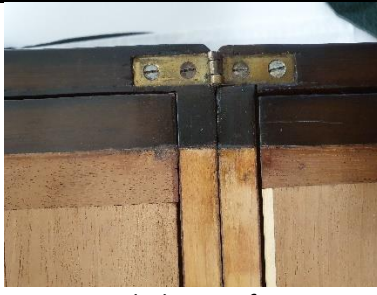
<p><i>Left hinge, after.</i></p>

<p><i>Right hinge, after.</i></p>

<p><b>Dirt/Dust</b></p>	<p>The box was brush vacuumed, to ensure that all dirt and grit has been removed before any work is done. This included under the lifted veneer and inside the box. The box was cleaned with a mix of diluted soap and water solution. Applied by using a cotton bud. The test to ensure no whiting of finish (Bloom) where moisture could penetrate the finish, was clear. Therefore, using the minimal amount of solution all surfaces where cleaned (McGiffin 1992 p.43).</p>	<div data-bbox="984 1016 1503 1402" data-label="Image"> </div> <p data-bbox="1052 1402 1433 1432"><i>Inside of box before brush vacuum.</i></p>
<p><b>Hardware</b></p>		
<p>Lock</p>	<p>Contact with the Key Hole Surgeon Melbourne determined that it is possible to cut a new key for the lock. The lock is currently in Melbourne getting a new key. This lock will be back in Canberra to be fitted mid-November.</p>	
<p>Hinge</p>	<p>Both hinges have been replaced. The hinges are original from the same era, that were sourced though Traditional Furniture Restorer. The original hinge was to bent to re straightened so that the box would sit together correctly.</p>

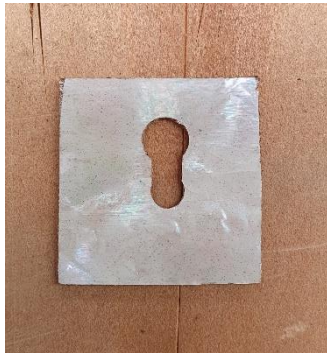
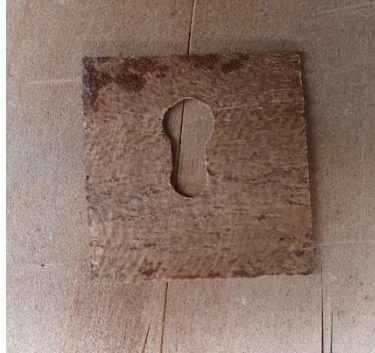
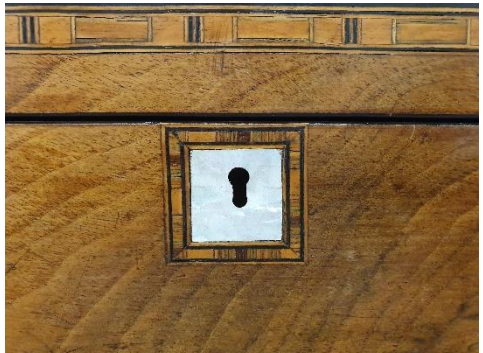
<p><i>Front of escutcheon</i></p>

<p><i>Back of escutcheon</i></p>

<p><i>Fitted escutcheon</i></p>
<p><b>Other:</b></p>			
<p>Hessian bottom covering</p>	<p>The hessian bottom has been replaced with green felt, this will give greater protection to the surface that the box is placed on. The felt was adhered with hide glue.</p>

<p><i>Right hinge, before.</i></p>
<p>Mother of pearl escutcheon</p>	<p>Mother of Pearl tile sheet PVC backed sourced from Lumea, was back on veneer sheet with hid glue. This was then cut to size with scalpel. The key hole was drilled out and filed to shape.</p>

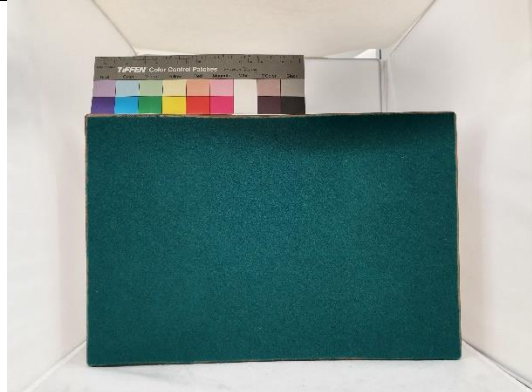
<p><i>Felt covered bottom, after.</i></p>	
<p>Broken divider</p>	<p>The joint has been cleaned up and resecured with hide glue.</p>

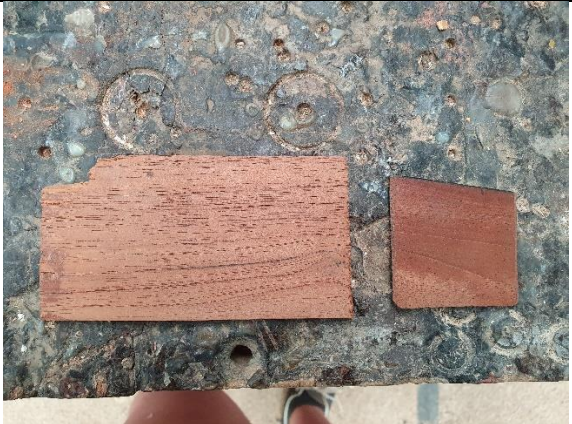
<p><i>Cedar piece on left, original divider on right to match to.</i></p>	  <p><i>The replacement divider on left, original divider on right.</i></p>
Broken catch hole	The bottom slope catch hole has been filled with epoxy putty. The hole was drilled out to fit the slide catch.	
Old veneer repair	The old veneer repair has been reglued down with hide glue, and left as is for the provenance of the box to be told.	
	  <p><i>Old repair, before.</i></p>	  <p><i>Old repair, After.</i></p>
Black marker	Black marker cleaned off with soap cleaning solution with ease.	
	  <p><i>Black marker, Before.</i></p>	  <p><i>Black marker, After.</i></p>
Slope timber shrinkage	The bottom slope was able to be dismantle into three pieces, old repair glue was clean off and pieces where re adhered with hide glue with correct alignment (Rodd 1076 p23).	
Slope covering	The old leatherette was removed. The new leather covering will made out of antique green coloured goat skin leather. The leather will have a gold leaf pressed edge. The leather will be adhered with hide glue. The leather slope is not complete yet, and will be complete on the 4/11/2019, this is due to access of gilding tools. I have the opportunity to be taught by Robin Tait on how to complete a gilded leather slope. I think this will be the best option for retaining this box's ethnicity and to build on my own experience.

<p>Missing Divider</p>	<p>New divider was cut out of cedar to match original timber. The top edge has been painted with pigments and shellac to blend repair.</p>

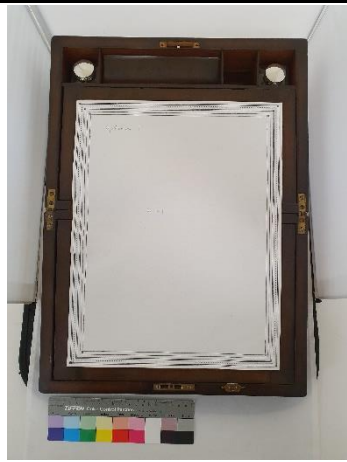
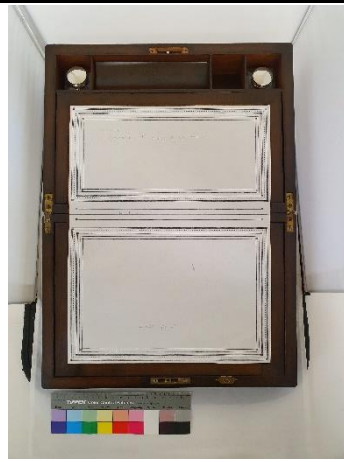
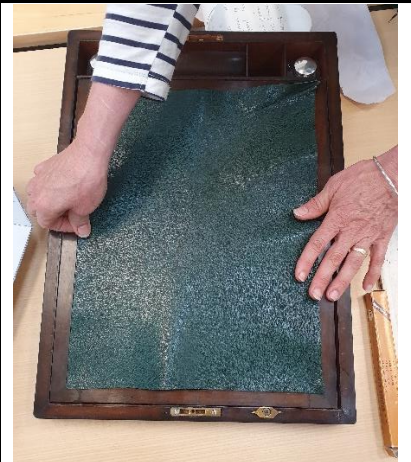
*Gold tooling option one.*

*Gold tooling option two*

*Green goat leather insert.*

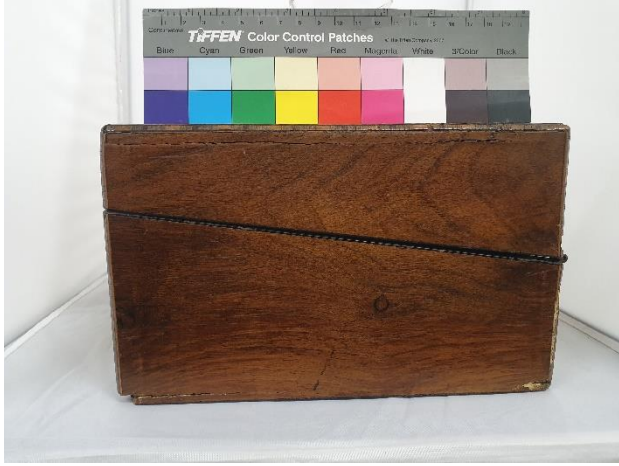
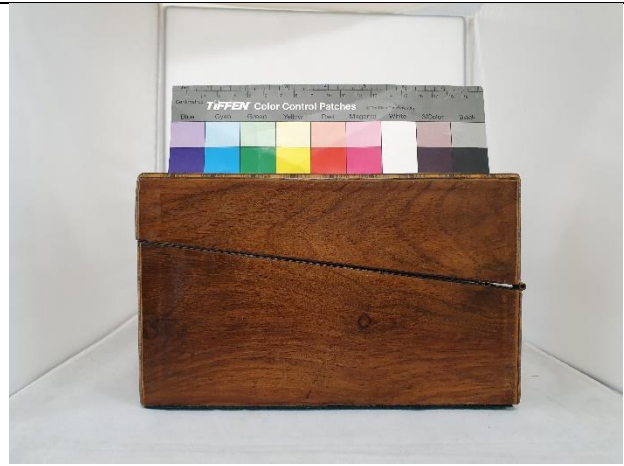
*Right side Before*

*Right side After*

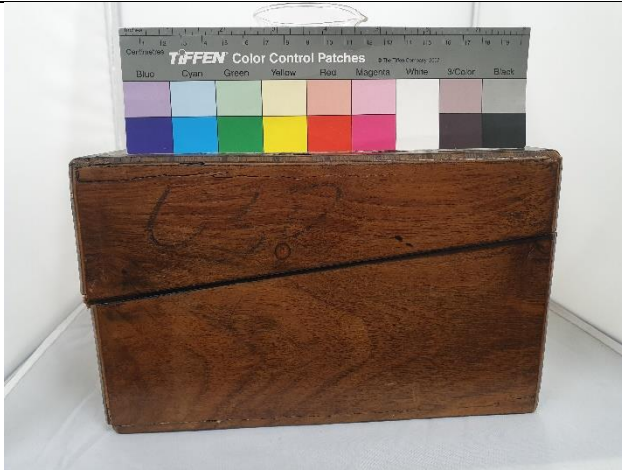
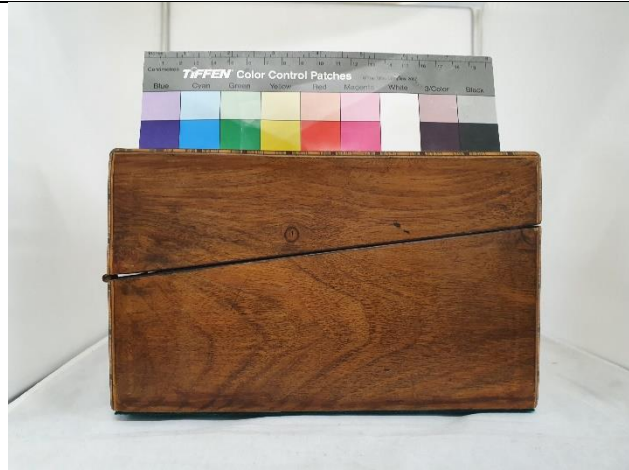
*Left side Before*

*Left side After*

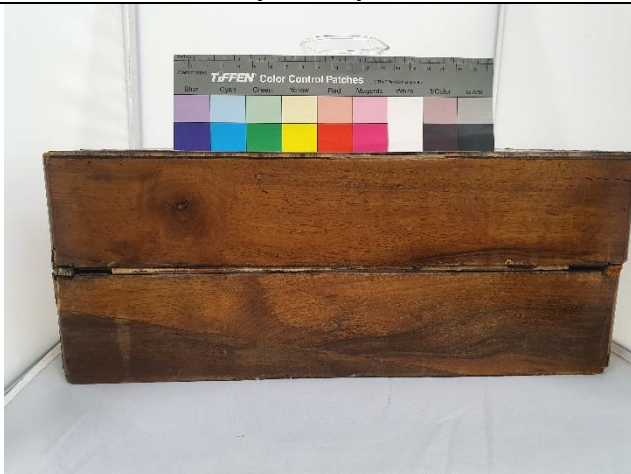
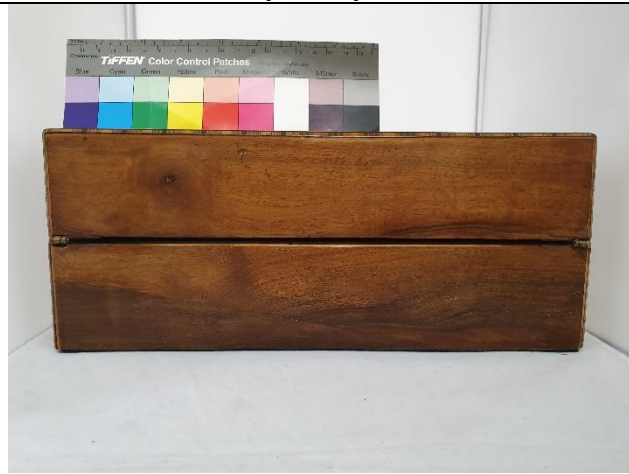
*Back Before*

*Back After*
